# Varnish Removal Unit

Solution for removal of dissolved and suspended  
soft contaminants from oil in

Gas & Steam Turbines

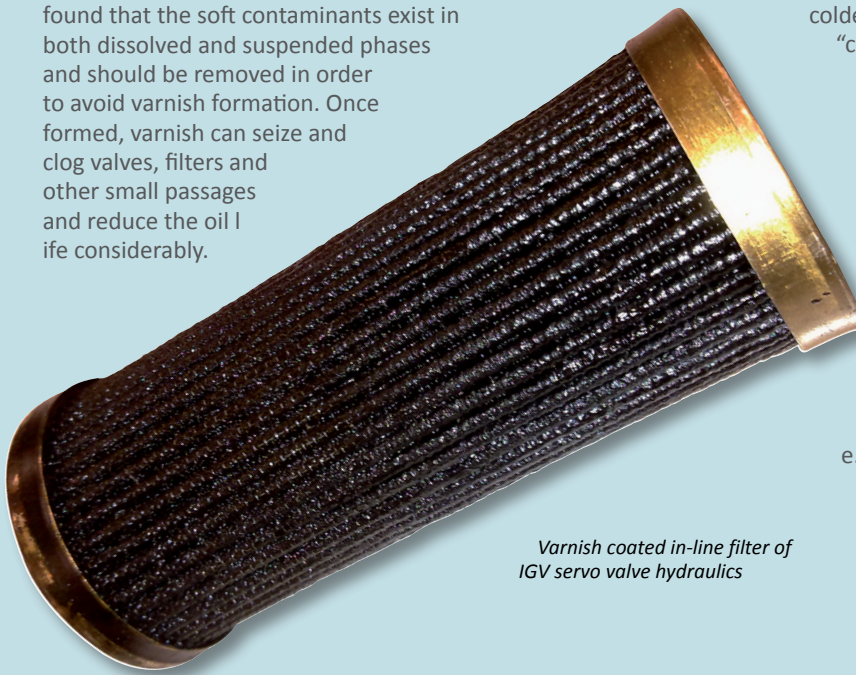
*Varnish coated in-line filter of IGV servo valve hydraulics*

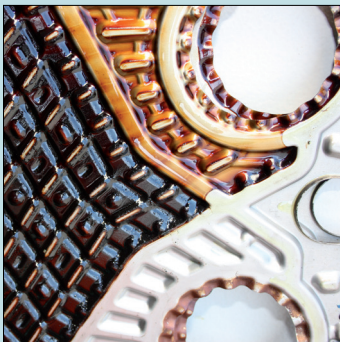
*Varnish on plate heat exchanger*

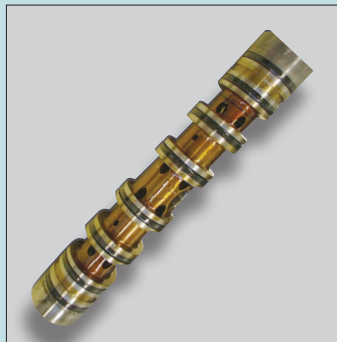
*Varnish on valve spool*
